OFFICIAL TEST REPORT

Q-LINE[®] POST SYSTEM

TOP MOUNT MOD 0917.448

REPORT NUMBER: **HETI-16-5089**

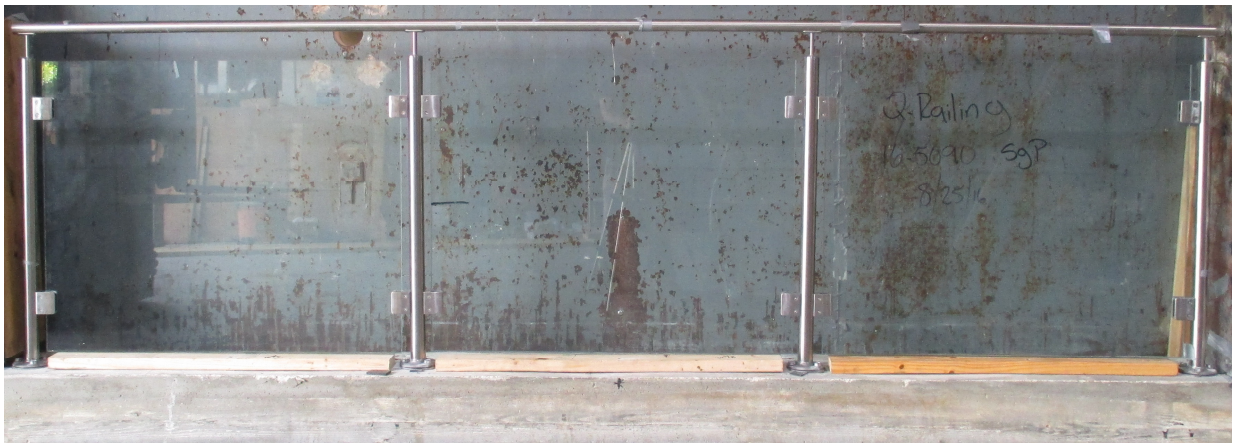
(Interior View)

PRODUCT: 1.9" Double Tube Post Top Mount Model 24 Clamps

PRODUCT SIZE: 149 wide x 42 3/4" high

Number of Specimens	1
Method of Choosing	Provided by Manufacturer
Size of Specimen	149" wide x 42 ¾" high
Configuration	Fixed
Post to Post Distance	48"
Hand Rail	Top rail was installed

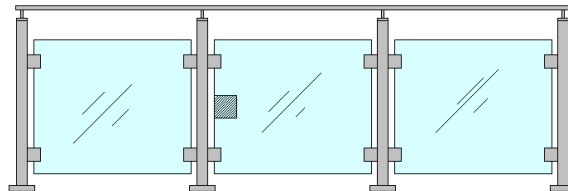
TEST RESULTS (16-5089)**4" Infill Test (Lateral Load)****Test Date:** August 23, 2016

Description of Location	Duration (sec)	Force Applied (lbs)
Center of Edge of Middle Lite	300	112.4
Center of Edge of Middle Lite	300	187

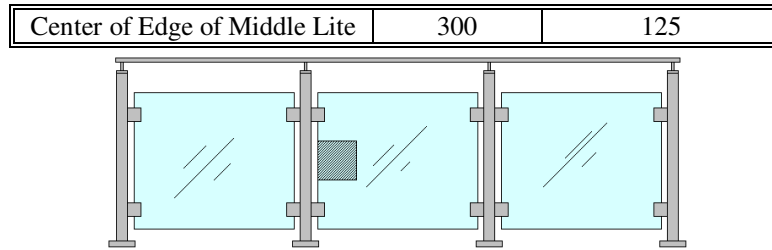
**12" Infill Test (Lateral Load)****Test Date:** August 23, 2016

Description of Location	Duration (sec)	Force Applied (lbs)
Center of Edge of Middle Lite	300	50

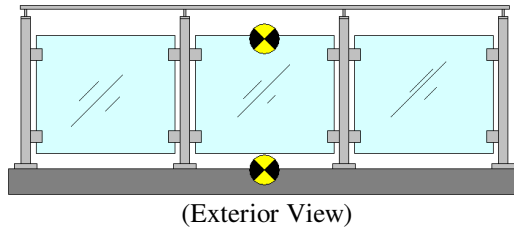
Pressure (psf)	Def. Loc #1 (In)	Def. Loc #2 (In)	Set Loc1/Loc 2 (In)	Recovery Loc 1 (%)	Duration (sec)
Positive Pressure						
Half Test Load	---	---	---	---	---	---
Design Load	+ 50	1.59	0.07	0.00/0.04	100	30
Test Load	+100	2.95	0.06	0.34/0.02	89	30
Negative Pressure						
Half Test Load	---	---	---	---	---	---
Design Load	- 50	1.83	0.11	0.00/0.06	100	30
Test Load	-100	4.02	0.26	0.00/0.01	94	30

Uniform Load Test was performed with ASTM E330-14 test method. See Figure for Loc1 & Loc2.

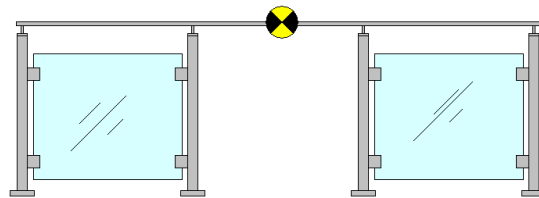
Horizontal and Vertical Loading per ASTM E935-00 (Reapproved 2006) Sec. 4.3 (AC 439) and ASTM E2358-04 (Reapproved 2010) Level 2/ Type L-2

Description of Location	Duration (sec)	Force Applied (lbs)
Horiz. Center of Top Rail	60	125
Vert. Center of Top Rail	60	172
Center Glass was removed prior to applying load. Railing and Glass were intact and no damaged was observed.

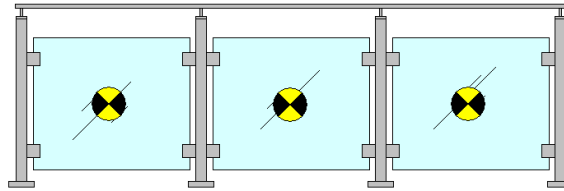
☢ - Impact Locations (interior view)

The test specimen as described in construction details was tested. The sample was impacted at center of each glass with a 100-pound lead Impactor. The Impactor was constructed as specified in ANSI Z97.1-1984 (R1994). The drop height and test results are summarized in table below.

No.	Drop Height (in)	Results
Center of Left Glass Lite		
1	12	Glass was intact and no damaged was observed.
2	18	Glass was intact and no damaged was observed.
3	48	Glass was intact and no damaged was observed.
Center of Middle Glass Lite		
1	12	Glass was intact and no damaged was observed.
2	18	Glass was intact and no damaged was observed.
3	48	Glass was intact and no damaged was observed.
Center of Right Glass Lite		
1	12	Glass was intact and no damaged was observed.
2	18	Glass was intact and no damaged was observed.
3	48	Back glass lite shattered. Glass panel stayed intact.

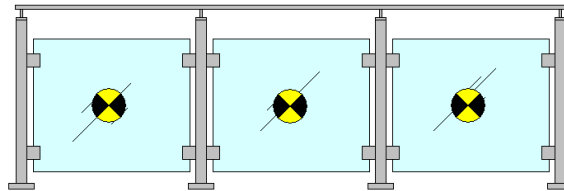
☢ - Impact Locations (interior view)

Location	Horizontal Impact Energy (ft-lbf)	Results
Center of Left Glass Lite	74	Glass was intact and no damaged was observed.
Center of Middle Glass Lite	74	Glass was intact and no damaged was observed.
Center of Right Glass Lite	74	Glass was intact and no damaged was observed.

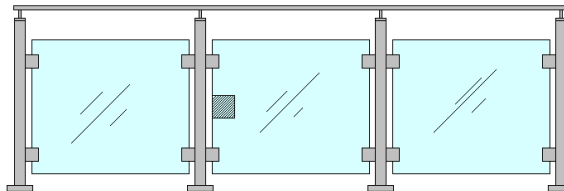
4" Infill Test (Lateral Load) (16-5090)

Description of Location	Duration (sec)	Force Applied (lbs)
Center of Edge of Middle Lite	300	112.4
Center of Edge of Middle Lite	300	187

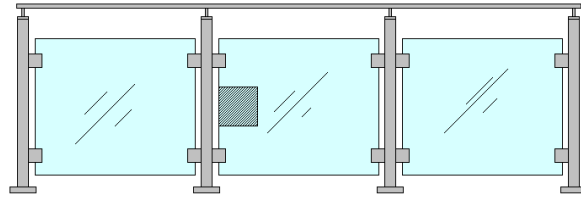
12" Infill Test (Lateral Load) (16-5090)

Description of Location	Duration (sec)	Force Applied (lbs)
Center of Edge of Middle Lite	300	50
Center of Edge of Middle Lite	300	125

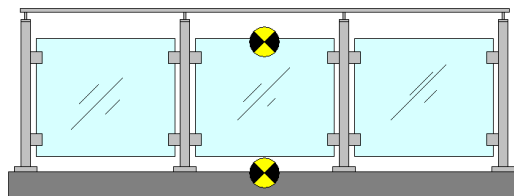
(Exterior View)

Pressure (psf)	Def. Loc #1 (In)	Def. Loc #2 (In)	Set Loc1/Loc 2 (In)	Recovery Loc 1 (%)	Duration (sec)
Positive Pressure						
Half Test Load	---	---	---	---	---	---
Design Load	+ 50	1.61	0.15	0.16/0.08	90	30
Test Load	+100	3.19	0.22	0.32/0.02	90	30
Negative Pressure						
Half Test Load	---	---	---	---	---	---
Design Load	- 50	1.23	0.04	0.11/0.01	91	30
Test Load	-100	2.54	0.06	0.30/0.02	88	30

Uniform Load Test was performed with ASTM E330-14 test method. See Figure for Loc1 & Loc2.

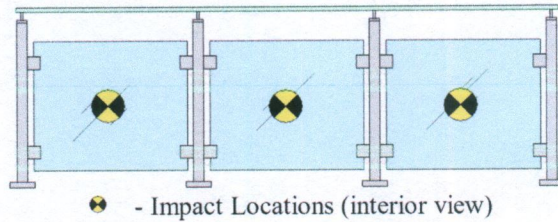
The test specimen as described in construction details was tested. The sample was impacted at center of each glass with a 100-pound lead Impactor. The Impactor was constructed as specified in ANSI Z97.1-1984 (R1994). The drop height and test results are summarized in table below.

No.	Drop Height (in)	Results
Center of Left Glass Lite		
1	12	Glass was intact and no damaged was observed.
2	18	Glass was intact and no damaged was observed.
3	48	Glass was intact and no damaged was observed.
Center of Middle Glass Lite		
1	12	Glass was intact and no damaged was observed.
2	18	Glass was intact and no damaged was observed.
3	48	Glass was intact and no damaged was observed.
Center of Right Glass Lite		
1	12	Glass was intact and no damaged was observed.
2	18	Glass was intact and no damaged was observed.
3	48	Glass was intact and no damaged was observed.

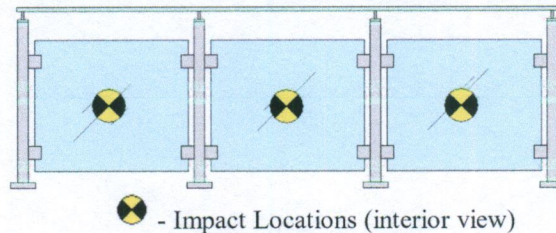
Location	Horizontal Impact Energy (ft-lbf)	Results
Center of Left Glass Lite	74	Glass was intact and no damaged was observed.
Center of Middle Glass Lite	74	Glass was intact and no damaged was observed.
Center of Right Glass Lite	74	Glass was intact and no damaged was observed.

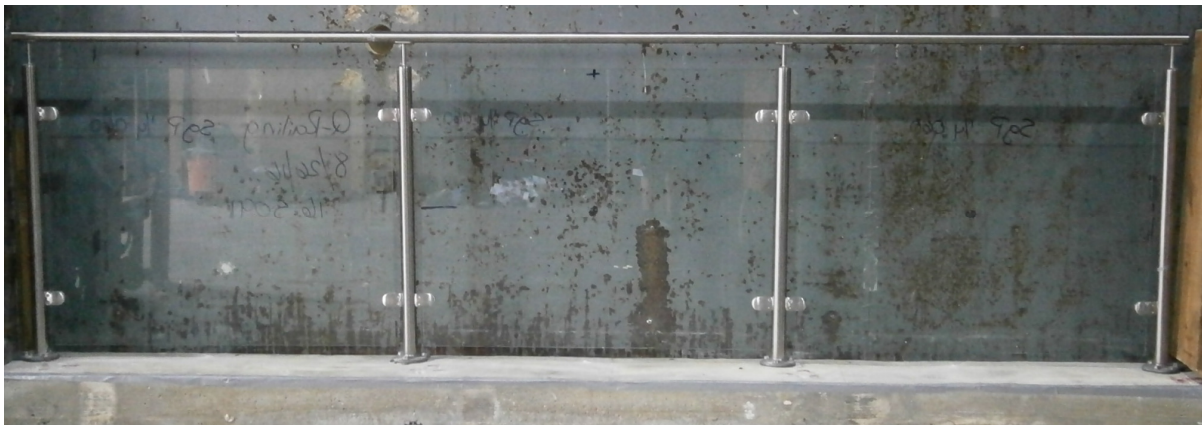
(Exterior View)

PRODUCT: 1.9" Double Tube Post Top Mount Model 28 Clamps

PRODUCT SIZE: 149" wide x 42 3/4" high

Number of Specimens	1
Method of Choosing	Provided by Manufacturer
Size of Specimen	149" wide x 42 ¾" high
Configuration	Fixed
Post to Post Distance	48"
Hand Rail	Top Rail was installed

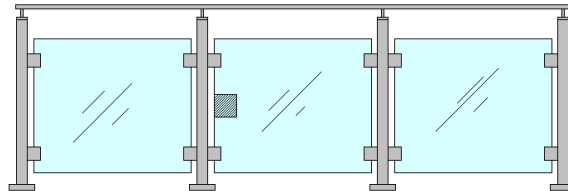
4" Infill Test (Lateral Load)

Description of Location	Duration (sec)	Force Applied (lbs)
Center of Edge of Middle Lite	300	112.4
Center of Edge of Middle Lite	300	187

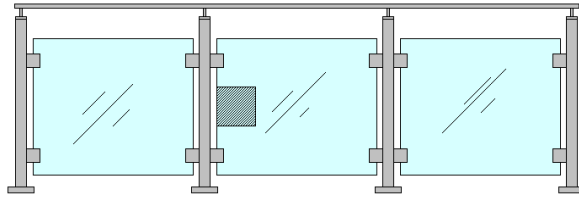
12" Infill Test (Lateral Load)

Description of Location	Duration (sec)	Force Applied (lbs)
Center of Edge of Middle Lite	300	50
Center of Edge of Middle Lite	300	125

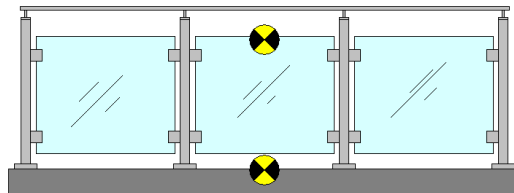
(Exterior View)

Pressure (psf)	Def. Loc #1 (In)	Def. Loc #2 (In)	Set Loc1/Loc 2 (In)	Recovery Loc 1 (%)	Duration (sec)
Positive Pressure						
Half Test Load	---	---	---	---	---	---
Design Load	+ 50	1.52	0.15	0.06/0.06	96	30
Test Load	+100	2.62	0.12	0.33/0.04	88	30
Negative Pressure						
Half Test Load	---	---	---	---	---	---
Design Load	- 50	1.75	0.08	0.17/0.02	90	30
Test Load	-100	3.80	0.40	0.65/0.01	83	30

Uniform Load Test was performed with ASTM E330-14 test method. See Figure for Loc1 & Loc2.

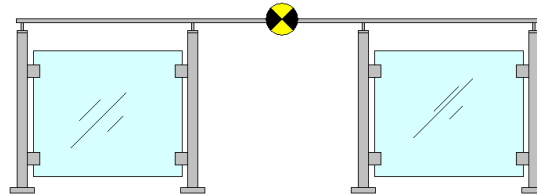
Horizontal and Vertical Loading per ASTM E935-00 (Reapproved 2006) Sec. 4.3 (AC 439) and ASTM E2358-04 (Reapproved 2010) Level 2/ Type L-2

Description of Location	Duration (sec)	Force Applied (lbs)
Horiz. Center of Top Rail	60	125
Vert. Center of Top Rail	60	172
Center Glass was removed prior to applying load. Railing and Glass were intact and no damaged was observed.

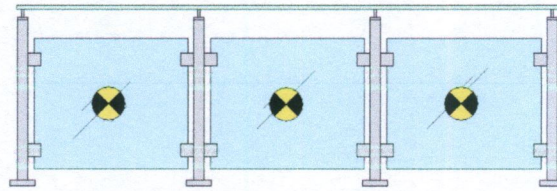
- Impact Locations (interior view)

The test specimen as described in construction details was tested. The sample was impacted at center of each glass with a 100-pound lead Impactor. The Impactor was constructed as specified in ANSI Z97.1-1984 (R1994). The drop height and test results are summarized in table below.

No.	Drop Height (in)	Results
Center of Left Glass Lite		
1	12	Glass was intact and no damaged was observed.
2	18	Glass was intact and no damaged was observed.
3	48	Both glass lites shattered. Glass panel stayed intact.
Center of Middle Glass Lite		
1	12	Glass was intact and no damaged was observed.
2	18	Glass was intact and no damaged was observed.
3	48	Glass was intact and no damaged was observed.
Center of Right Glass Lite		
1	12	Glass was intact and no damaged was observed.
2	18	Glass was intact and no damaged was observed.
3	48	Back glass lite shattered. Glass panel stayed intact.

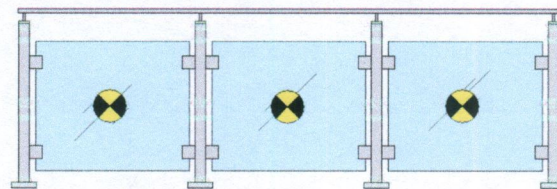
- Impact Locations (interior view)

Location	Horizontal Impact Energy (ft-lbf)	Results
Center of Left Glass Lite	74	Glass was intact and no damaged was observed.
Center of Middle Glass Lite	74	Glass was intact and no damaged was observed.
Center of Right Glass Lite	74	Glass was intact and no damaged was observed.

***Prior to test, all damaged glass was replaced.**
